EVALUATION OF  
CITY OF BOSTON  
PARK AND RECREATION LAND

NEIGHBORHOOD OF CENTRAL  
(CHINATOWN, DOWNTOWN, NORTH END)

Prepared for  
MAYOR'S OFFICE  
OF  
CAPITAL PLANNING

THE HALVORSON COMPANY, INC.  
LANDSCAPE ARCHITECTS AND  
SITE PLANNING CONSULTANTS  
161 MASSACHUSETTS AVENUE  
BOSTON, MASSACHUSETTS 02115

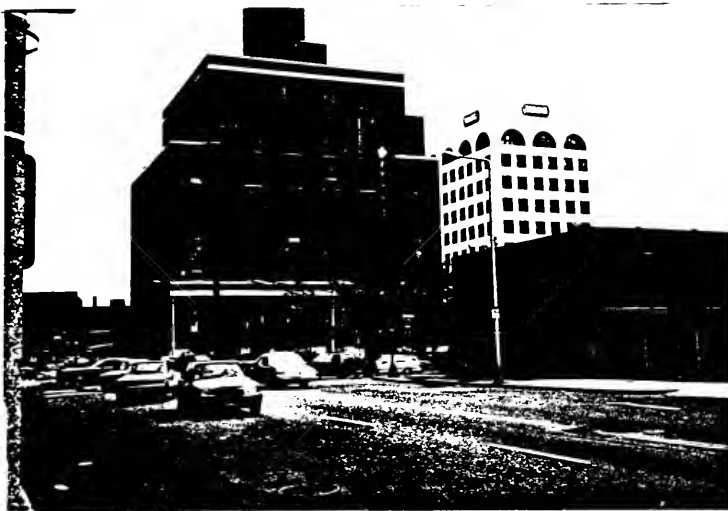
**Site Photograph 1**

Wang Center and parking at rear of site. Fencing to left delineates edge of parking. Possibly on park property.

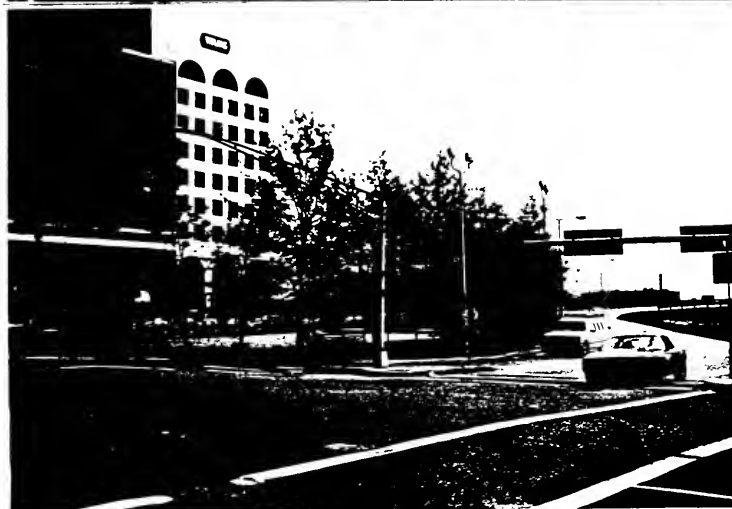
**Site Photograph 2**

Irregularly shaped park with no site improvements other than trees and grass.

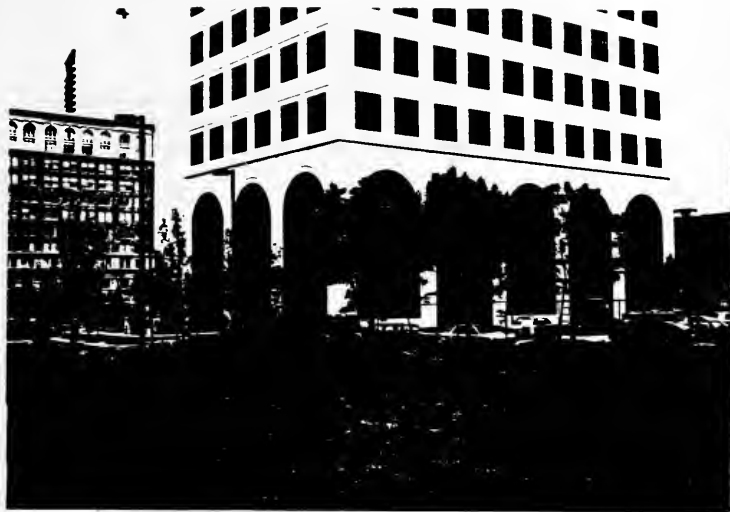
**Site Photograph 7**

Location of park poor,  
with weak street  
presence.

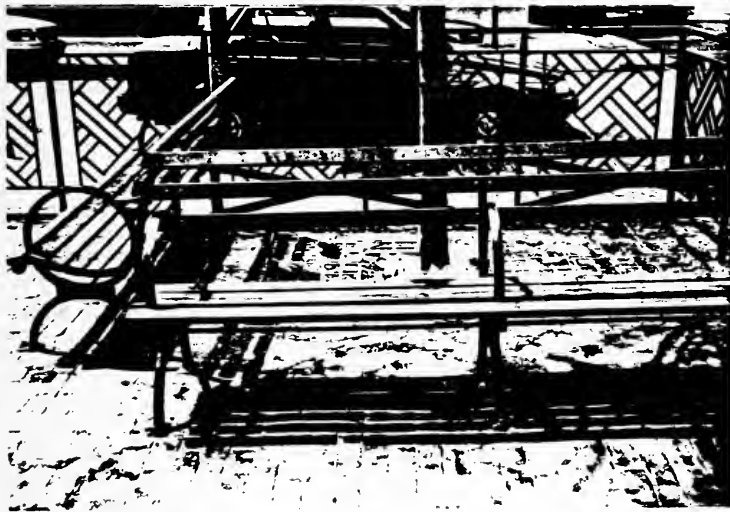
**Site Photograph 5**

Maintenance access to  
tree pits difficult due  
to location of benches.

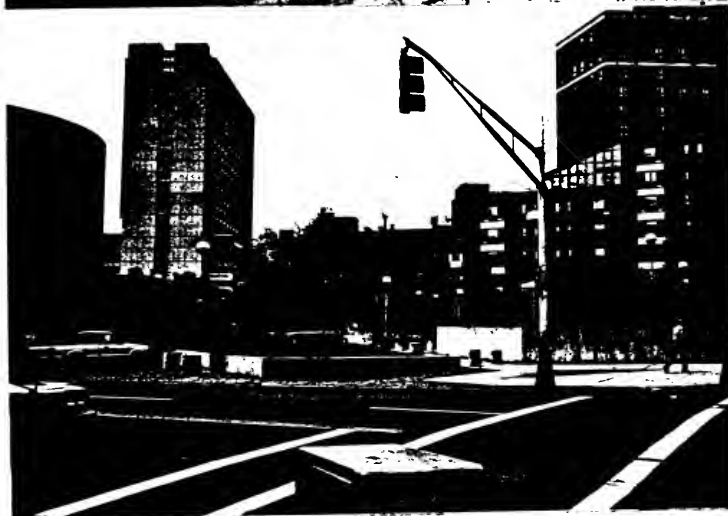
**Site Photograph 2**

View of site from across street. Walls and berms inhibit view into, or through site.

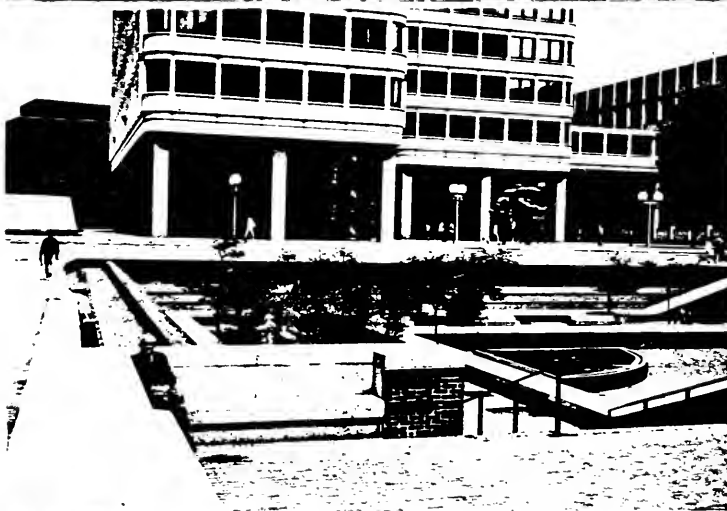
### Site Photograph 2

View into fountain and seating area. Fountain not working. Trees are poor choice due to thorns and not thriving.

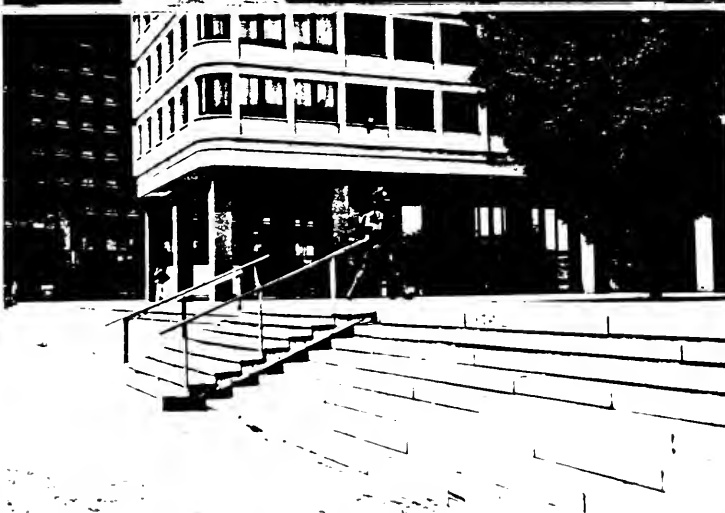
**Site Photograph 6**

Granite steps in poor condition. Temporary steps installed.

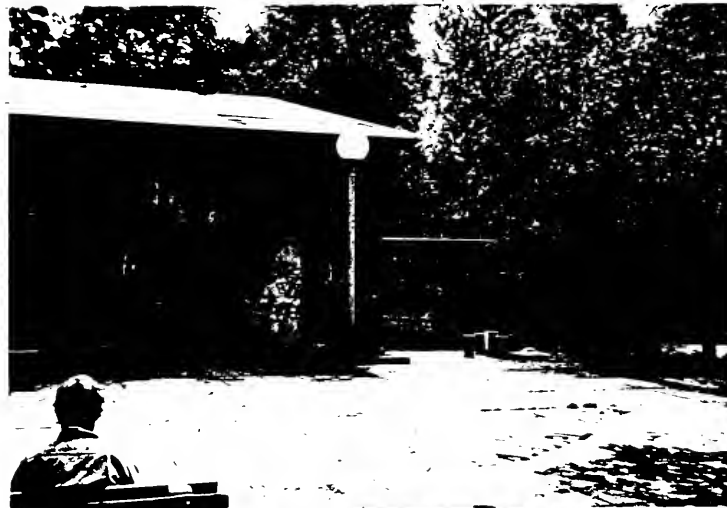
**Site Photograph 5**

Picnic shelter in state of disrepair. All game tables in unusable condition.

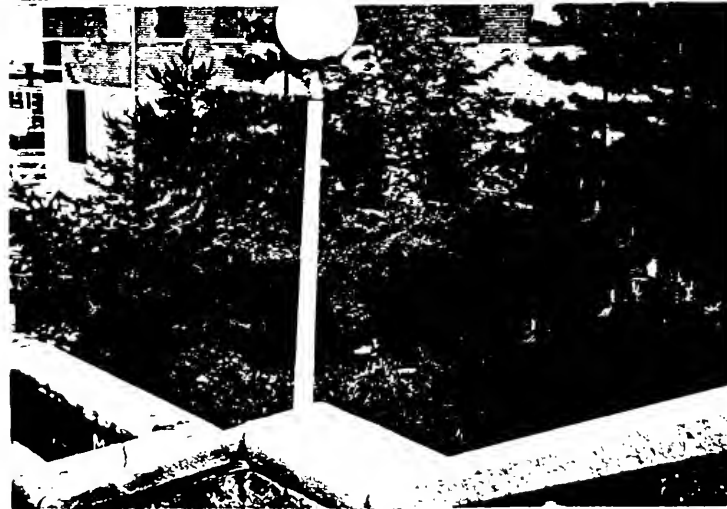
**Site Photograph 6**

Planting area in need of improved maintenance.

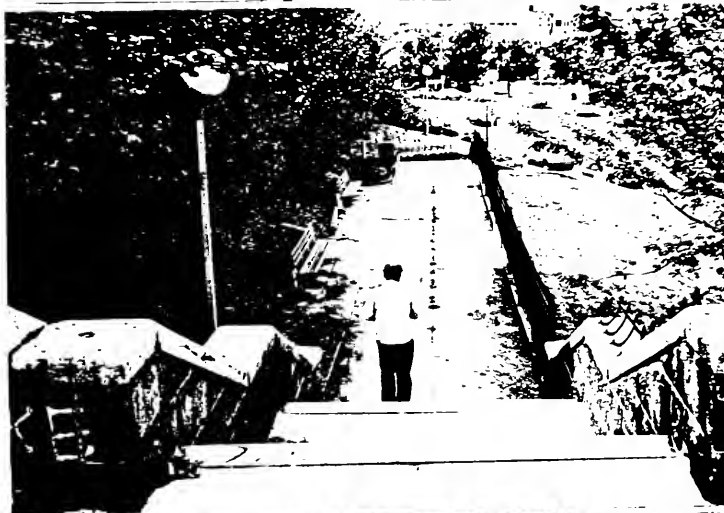
**Site Photograph 2**

View of walkway along back of first level. Pavement needs sweeping, removal and replacement of broken lamp post between benches.

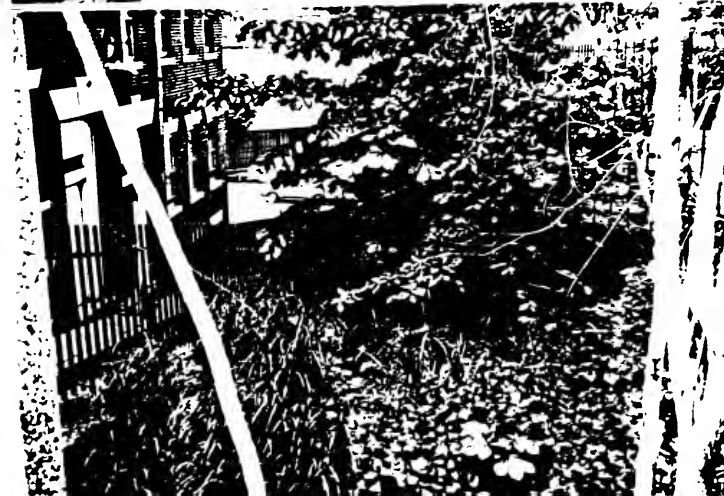
**Site Photograph 3**

Weed trees at right and herbaceous weeds need removal.

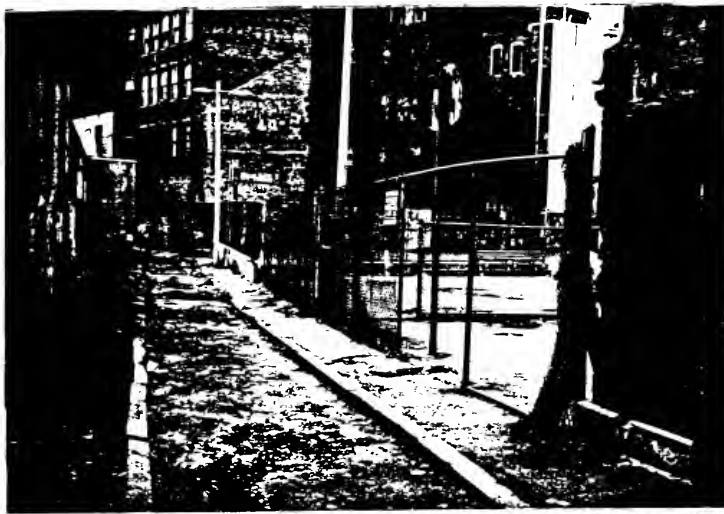
**Site Photograph 1**

View down Morton Street shows hidden character of park location. Chain link fence pulled back.

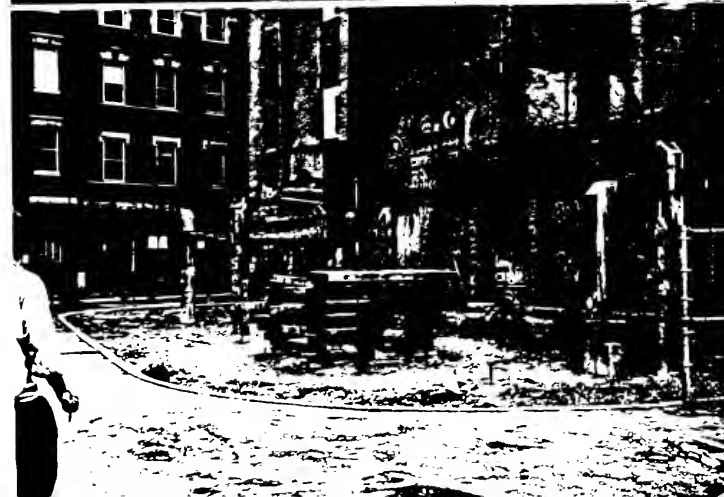
**Site Photograph 3**

Play area-- equipment shows numerous safety problems and missing parts. Safety surface very poor. Graffiti-covered walls dominate character of site.

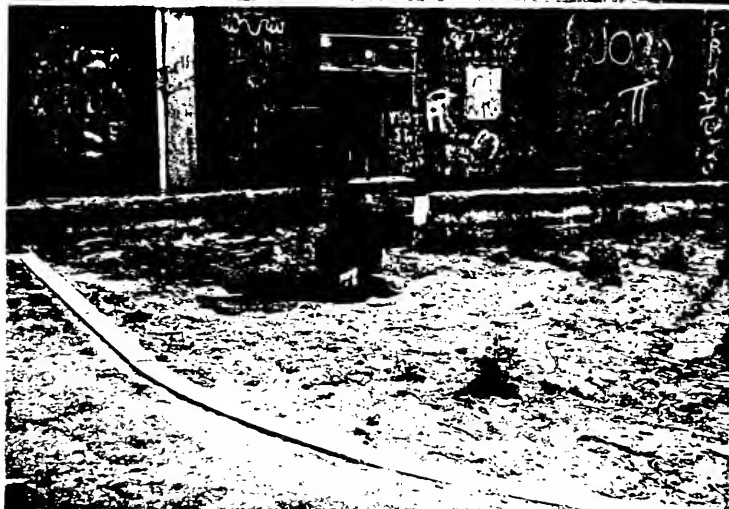
**Site Photograph 5**

Play surface very poor--  
trash, weeds, and  
animal waste.

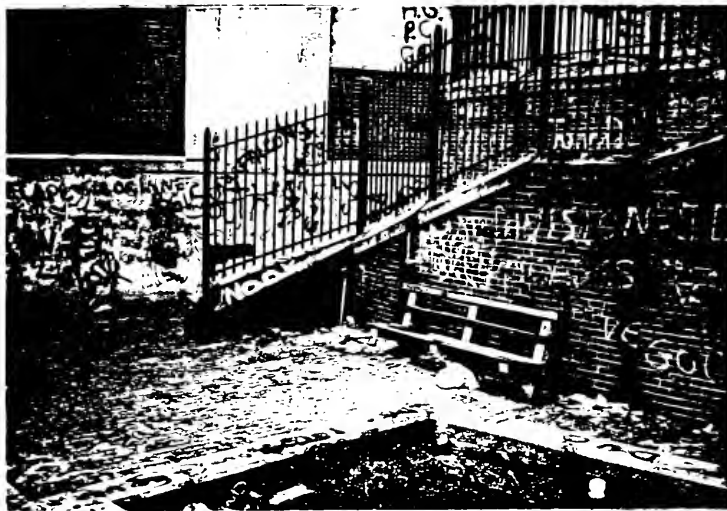
**Site Photograph 4**

Trash, graffiti,  
broken benches.

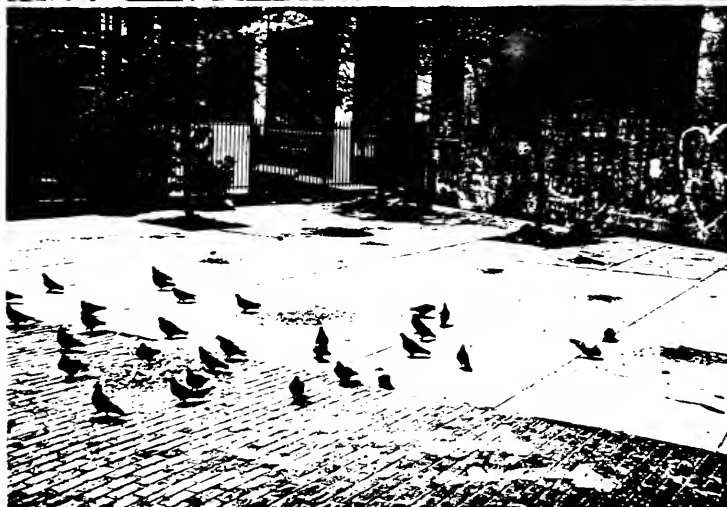
**Site Photograph 5**

Glass swept into piles,  
but not picked up.

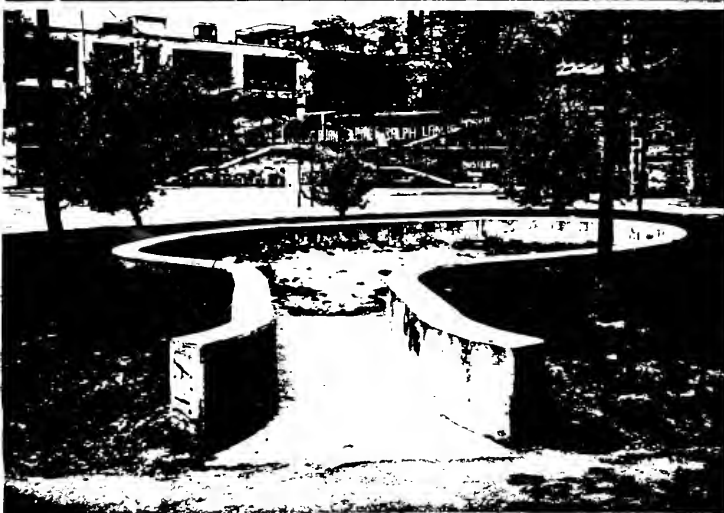
**Site Photograph 8**

Play area-- no equipment left.

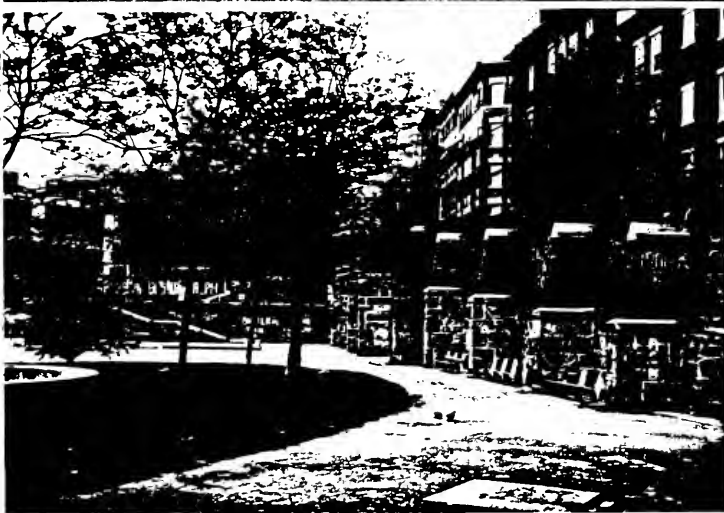
**Site Photograph 9**

Broken benches, graffiti on walls. Fencing along top of wall unnecessary.

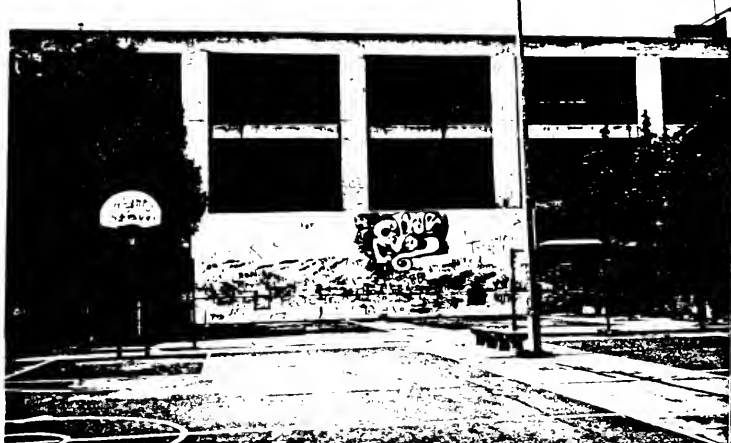
**Site Photograph 10**

Graffiti on handball court wall.

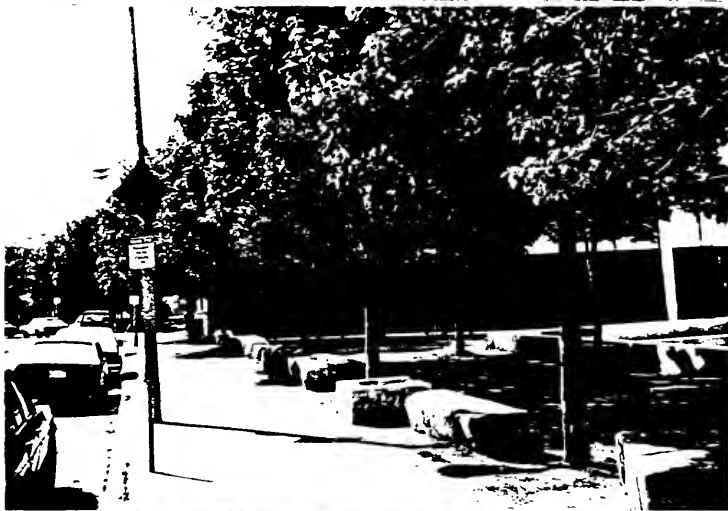
**Site Photograph 2**

Tree planting good along street edge. Haphazard placement of granite curbing visually detracts from edge.

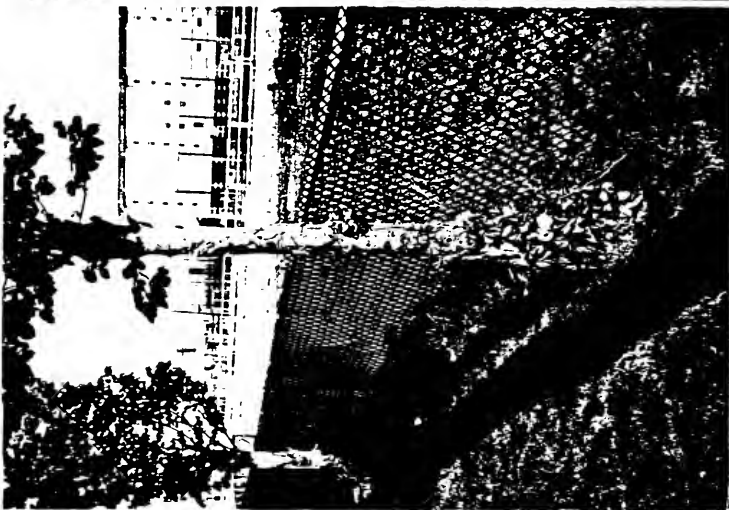
**Site Photograph 5**

Vandalism to tree.

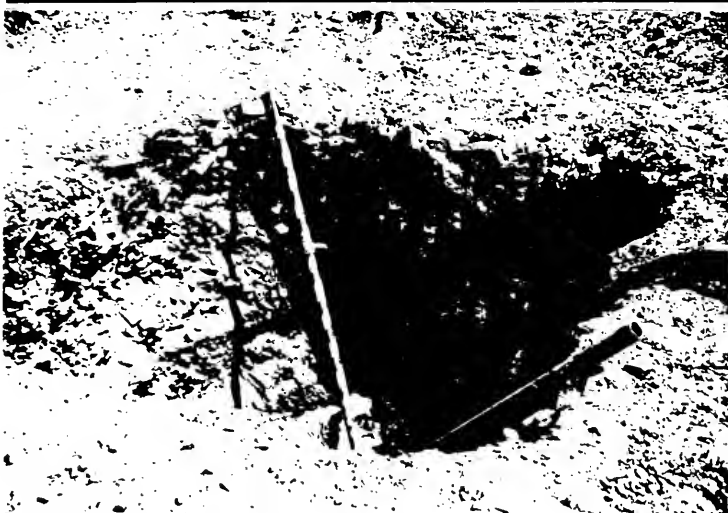
**Site Photograph 3**

Layers of rubble in  
subsoil provide a  
difficult growing  
environment for plants.

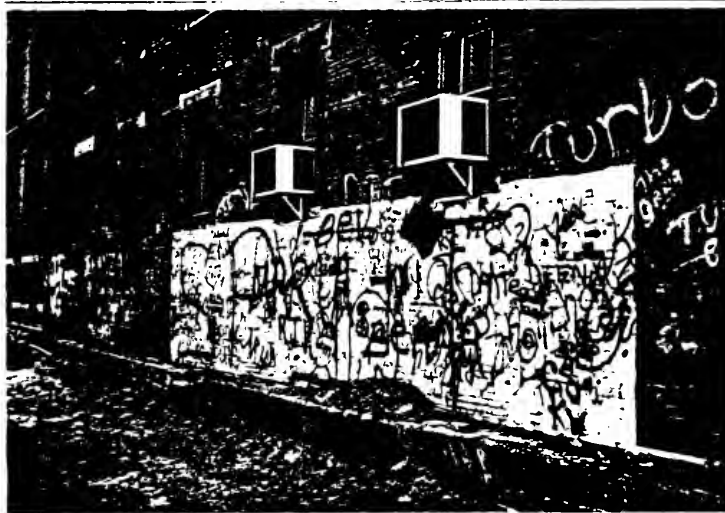
Site Photograph 5

Graffiti is a problem  
in this neighborhood.

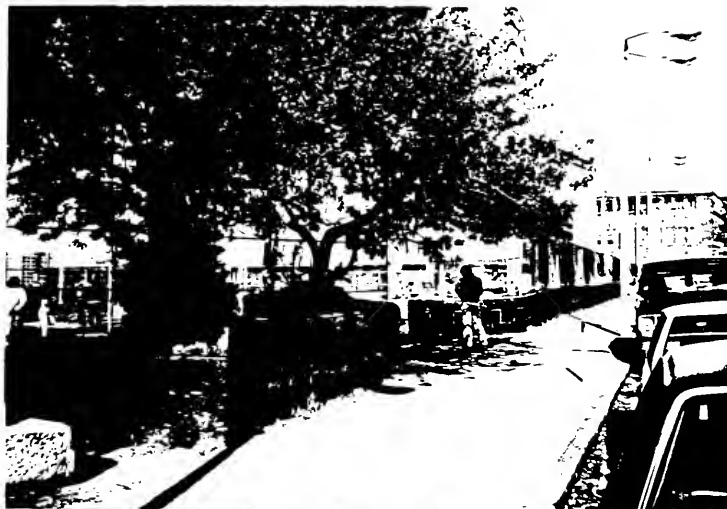
**Site Photograph 1**

Entry to park from Commercial Street-- shows good stone wall with capstone missing at left. Also the only two trees of the park.

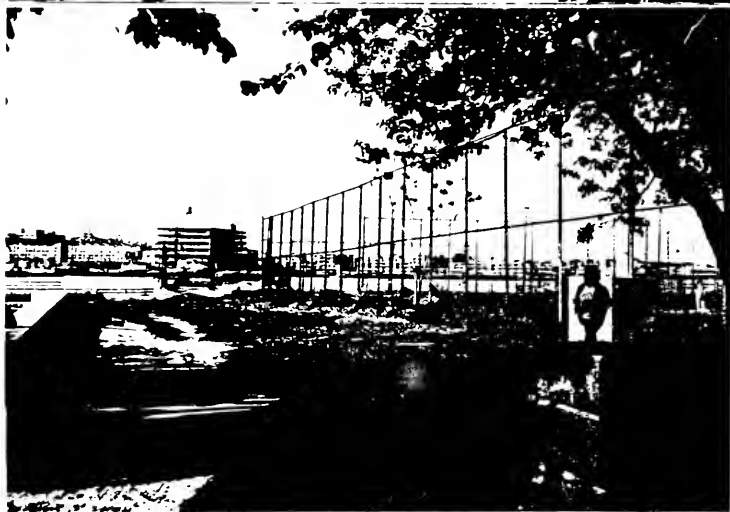
**Site Photograph 2**

Western edge of park. Grass poor.

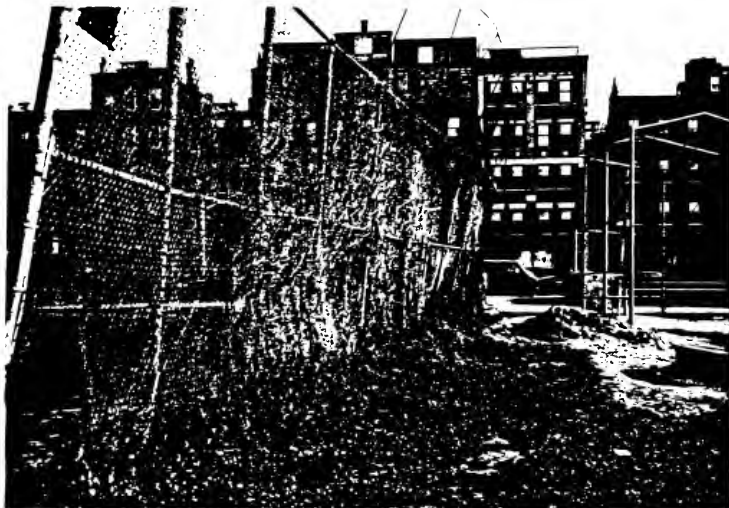
**Site Photograph 4**

Condition of fence and weed growth along base very poor. Infield mix located in area of pedestrian access.

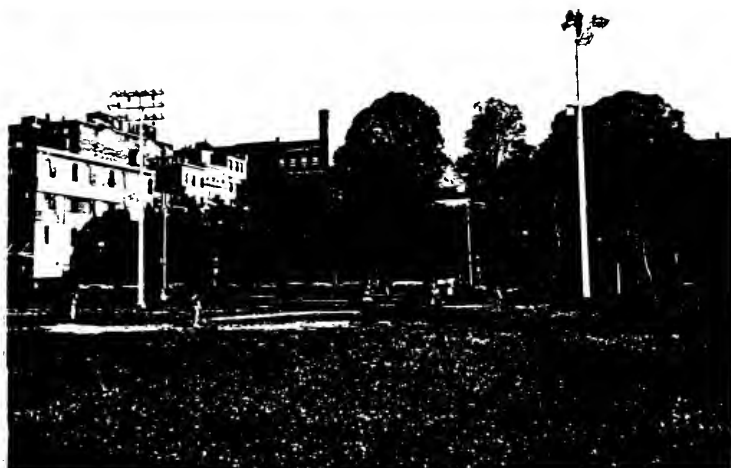
**Site Photograph 8**

Softball infield with bleachers behind. Condition of outfield very poor.

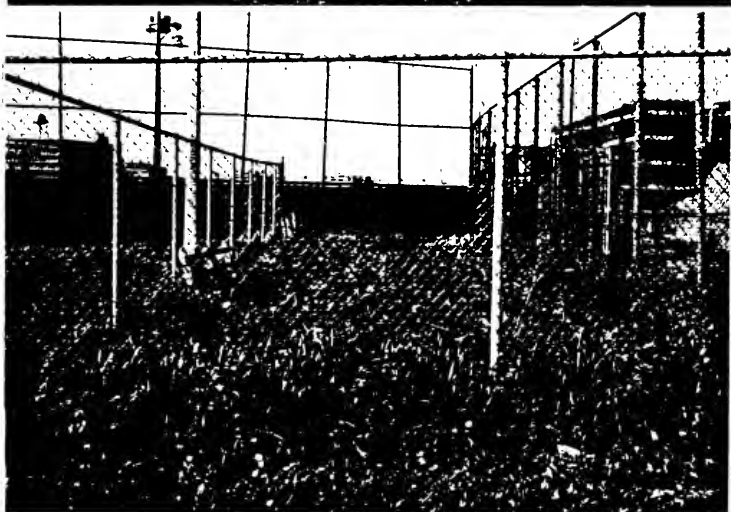
**Site Photograph 9**

Bocci court-- unusable and unsightly.

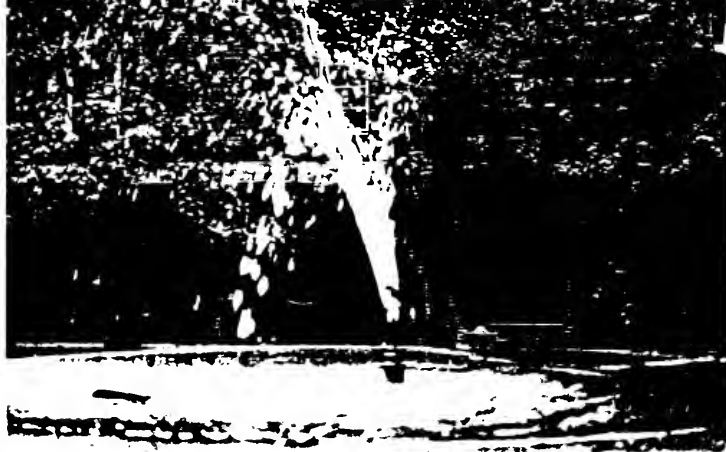
#### Site Photograph 4

Fountain repaired with shower head for jet.

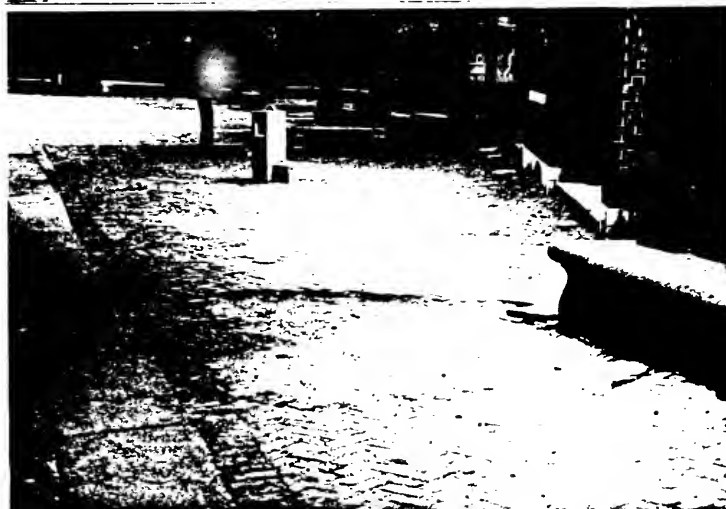
#### Site Photograph 5

Pavement needs repair in some areas.
